Manhole Inspection Summary

Manhole # S04II2024MH

Insp Date: **7/17/06 7:27 AM**

Location Address: **3210 BONNIE RD** Cross Street: **LABYRINTH RD**

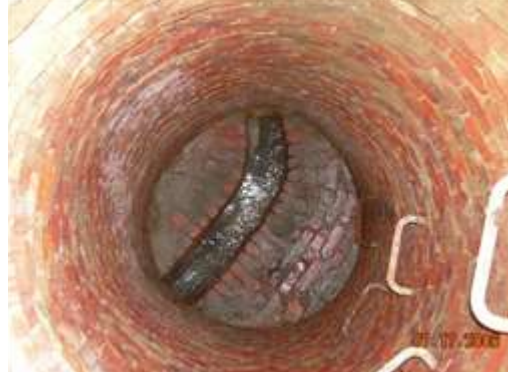
Top View

Evidence of surcharge - Bench debris.
Barrel infiltration. Corroded steps.

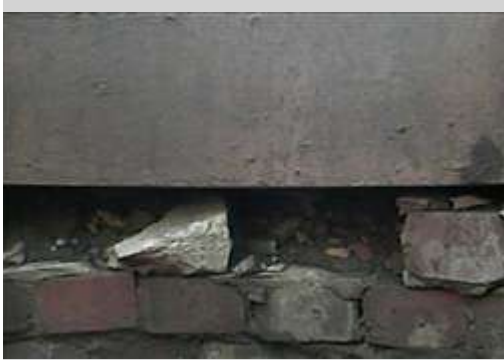
Defect

Frame leaks. Adjustment deterioration,
loose brick and infiltration.

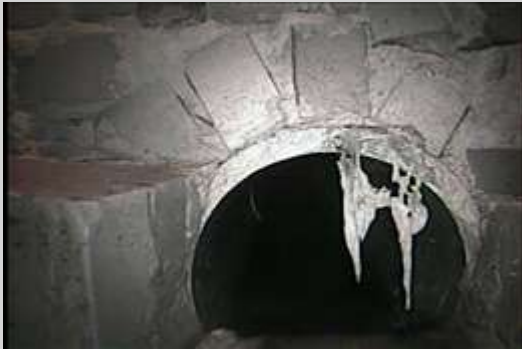
8 in. Circular Gravity Sewer Pipe Out @ 12 O'Clock

Infiltration: **Evidence** Pipe Seal Cond: **Roots**

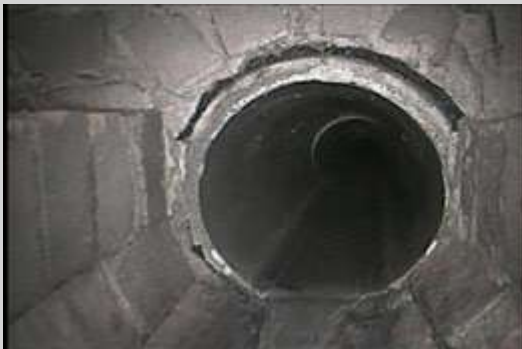
8 in. Circular Gravity Sewer Pipe In @ 7 O'Clock

Infiltration: **Evidence** Pipe Seal Cond: **Unknown**
